**Flood Control Project Maintenance  
Levee Inspections**  
**LMA District Cover Sheet**  
**Spring 2016 Levee Inspection Results**

**Reclamation District No. 0556 Upper Andrus**

**Spring 2016 Levee Inspection Results**

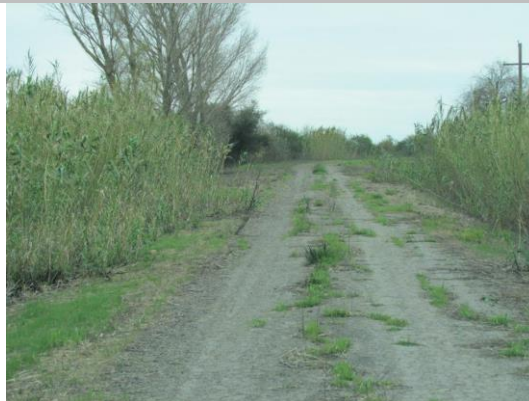
Photo 1 of 1 : SP\_2016\_RD0556\_18\_51\_20160512\_00063.jpg

LM Start	3.74	Rating **	U	Issue No.	51
LM End	5.47	Issue Type +	Ma	Location *	WS
Category	Earthen Levee			GPS Latitude/Longitude	
				Start	End
Item	Vegetation			38.203577 °	38.186492 °
				-121.541025 °	-121.562487 °
DWR ID	DWR_RD0556_01_s_2016_51				
Comment Code					
V2 : Remove the wild growth other than native grasses from the levee slopes.					
Inspector Comment					
Remove the arundo from the waterside shoulder and slope from 3.74-5.47.

Levee mile 3.74 - 5.47 arundo has taken over the waterside slope and shoulder.

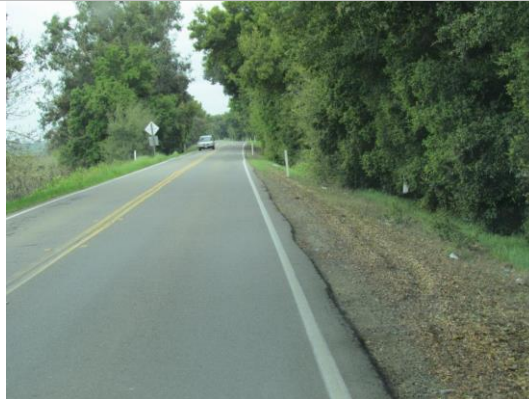
Photo 1 of 1 : SP\_2016\_RD0556\_19\_82\_20160512\_00056.jpg

LM Start	0.00	Rating **	U	Issue No.	82
LM End	2.47	Issue Type +	Ma	Location *	WS
Category	Earthen Levee			GPS Latitude/Longitude	
				Start	End
Item	Vegetation			38.200550 °	38.234418 °
				-121.544190 °	-121.557940 °
DWR ID	DWR_RD0556_02_s _ 2013_82				
Comment Code					
V2 : Remove the wild growth other than native grasses from the levee slopes.					
Inspector Comment					
Waterside levee slope and shoulder is covered with wild tree growth and other unsatisfactory vegetation.

RD 556 Unit 2 levee mile 0.00 looking at the water side levee slope.

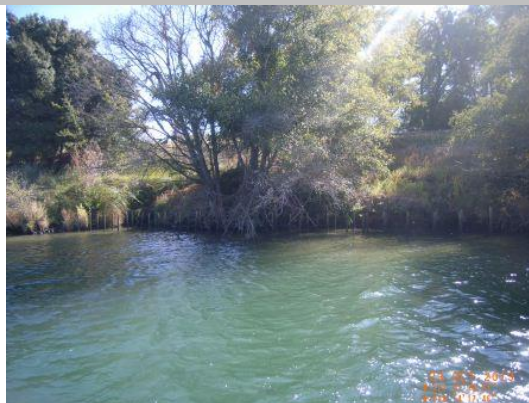
Photo 1 of 1 : SP\_2016\_RD0556\_19\_12\_20160223\_00010.jpg

LM Start	0.31	Rating **	M	Issue No.	12
LM End	0.60	Issue Type +	Ma	Location *	WS
Category	Supplemental			GPS Latitude/Longitude	
				Start	End
Item	2015 USACE Erosion Survey, DRAFT			38.238784 °	38.237862 °
				-121.523932 °	-121.529188 °
DWR ID	DWR_RD0556_02_s_2016_12				
Comment Code					
Inspector Comment					
2002 - Two rockd sections (150 ft long) at the downstream end.					
2005 - Lots of old brush boxes, some with established vegetation in the area behind the boxes. 2006 - Some small spots fixed with stone.					
2009 - Minimal new erosion, rock in the middle of the reach may be new. 2011 - Minor new erosion at the toe. 2013 - Minor new erosion.					
2015: Site is currently under construction. [2015 Site ID: SAC_26-0_L]

USACE 2013 Photo #1

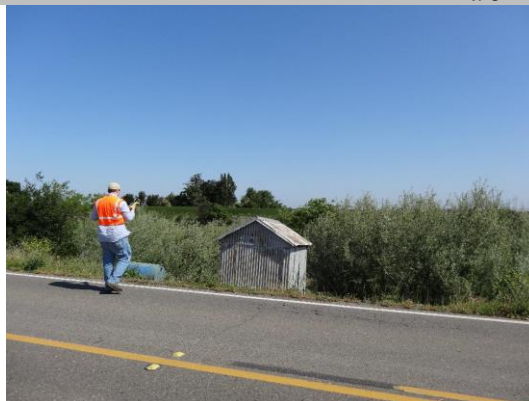
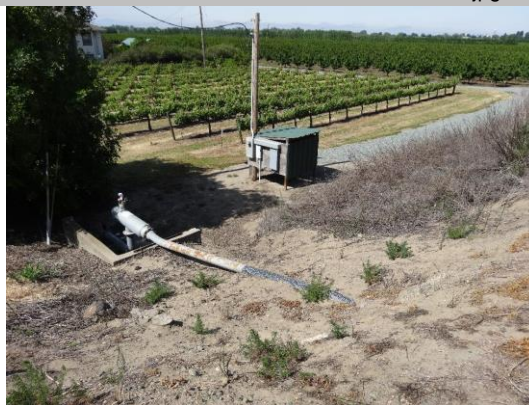
LM Start	0.94	Rating **	M	Issue No.	90
LM End	0.94	Issue Type +	En	Location *	LS
Category	Supplemental			GPS Latitude/Longitude	
				Start	End
Item	DWR UCIP Field Study			38.238125 °	38.238125 °
				-121.535267 °	-121.535267 °
DWR ID					
Comment Code					
Inspector Comment					
FS_ID:12512					
DS_ID:20851					
EP_NO: 11186					
Repair Type: Non-Urgent					
Crossing Status: Found					
UCIP Comments: - a concrete box on LS- water is leaking from priming plastic tank and causing surface erosion on levee slope.					
FIELD_STRUCT_DESC: 4-inch pipe through levee, 4.3-feet below crown. Pump in pump house on berm. Siphon breaker and service pole on landward slope. A concrete spillbox with 3-8-inch openings. (ABO #11186 - Marks). O&M Manual Sac 103, June 1954.					
FS Date: 4/25/2013

WS- pump house on levee berm

LS- steel pipe on a concrete box

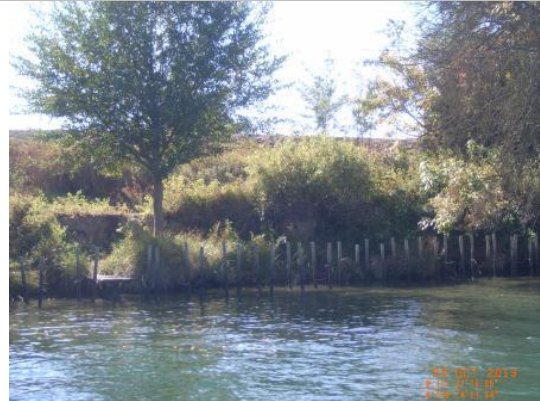
Photo 1 of 1 : SP\_2016\_RD0556\_19\_2\_20160223\_00002.jpg

LM Start	1.03	Rating **	M	Issue No.	2
LM End	1.15	Issue Type +	Ma	Location *	WS
Category	Supplemental			GPS Latitude/Longitude	
				Start	End
Item	2015 USACE Erosion Survey, DRAFT			38.238772 °	38.239265 °
				-121.536788 °	-121.538845 °
DWR ID	DWR_RD0556_02_s_2016_2				
Comment Code					
Inspector Comment					
1997 - Rock is in poor condition and has failed in many places. Scallops in berm with remnants of old rock in the toe area. 2005 - Brush boxes present. 2013 - Site extended upstream approximately 300 ft to include new erosion pockets. 2015: Minor new erosion at toe. [2015 Site ID: SAC_25-2_L]

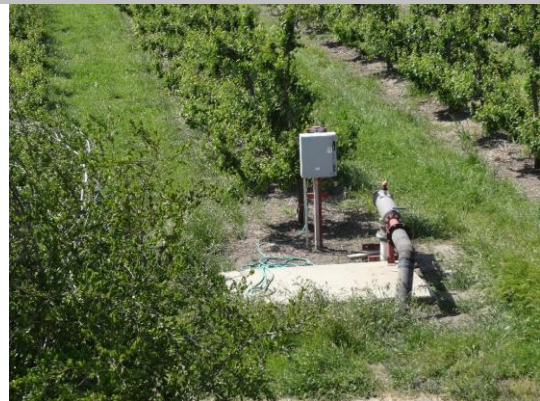
Photo 1 of 2 : UCIP\_SP\_2016\_12573\_20381.jpg

LM Start	1.22	Rating **	M	Issue No.	99
LM End	1.22	Issue Type +	En	Location *	WS
Category	Supplemental			GPS Latitude/Longitude	
				Start	End
Item	DWR UCIP Field Study			38.239327 °	38.239327 °
				-121.540190 °	-121.540190 °
DWR ID					
Comment Code					
Inspector Comment					
FS_ID:12573					
DS_ID:20852					
EP_NO: 11187					
Repair Type: Non-Urgent					
Crossing Status: Found					
UCIP Comments: - gap between 6-inch pipe and 10-inch pipe needs to be sealed.					
FIELD_STRUCT_DESC: A 6-inch steel pipe sleeved through 10-inch pipe through levee, 4.8 feet below crown. Pump on waterside of the levee on river bank. (ABO #11187 Machado).					
FS Date: 4/25/2013

LS- 6-inch steel pipe on orchard.

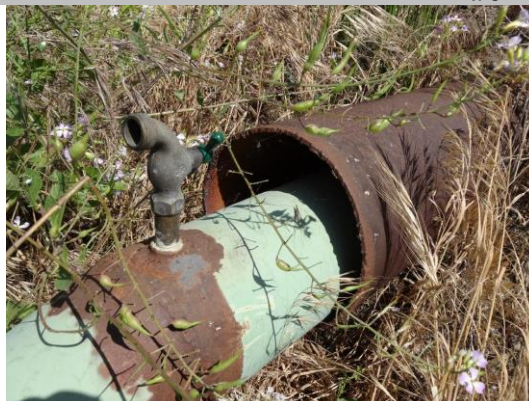
Photo 2 of 2 : UCIP\_SP\_2016\_12573\_20380.jpg

LM Start	1.22	Rating **	M	Issue No.	99 (cont)	
LM End	1.22	Issue Type +	En	Location *	WS	
Category	Supplemental			GPS Latitude/Longitude		
				Start	End	
Item	DWR UCIP Field Study			38.239327 °	38.239327 °	
				-121.540190 °	-121.540190 °	
DWR ID						
Comment Code						
Inspector Comment						
FS_ID:12573 DS_ID:20852 EP_NO: 11187 Repair Type: Non-Urgent Crossing Status: Found UCIP Comments: - gap between 6-inch pipe and 10-inch pipe needs to be sealed. FIELD_STRUCT_DESC: A 6-inch steel pipe sleeved through 10-inch pipe through levee, 4.8 feet below crown. Pump on waterside of the levee on river bank. (ABO #11187 Machado). FS Date: 4/25/2013

LS- 6-inch steel pipe sleeved through 10-inch steel pipe. 6" pipe is attached with air release valve.

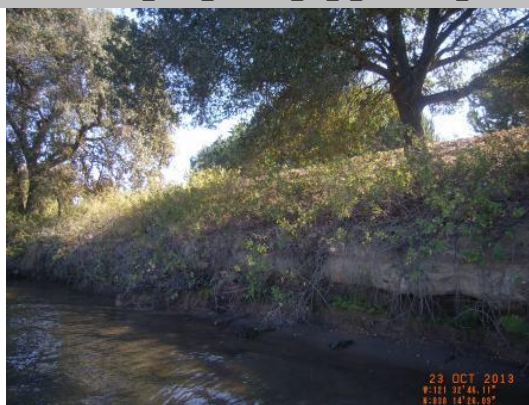
Photo 1 of 1 : SP\_2016\_RD0556\_19\_5\_20160223\_00005.jpg

LM Start	1.45	Rating **	M	Issue No.	5
LM End	1.59	Issue Type +	Ma	Location *	WS
Category	Supplemental			GPS Latitude/Longitude	
				Start	End
Item	2015 USACE Erosion Survey, DRAFT			38.240401 °	38.240772 °
				-121.544106 °	-121.546791 °
DWR ID	DWR_RD0556_02_s_2016_5				
Comment Code					
Inspector Comment					
1997 - Slow erosion of the berm at the waterline; bench below water. 2005 - Brush boxes present. 2010 - Minor new erosion. 2013 - There is little to no berm remaining at downstream end of this site. 2015: No observed changes. [2015 Site ID: SAC_24-8_L]

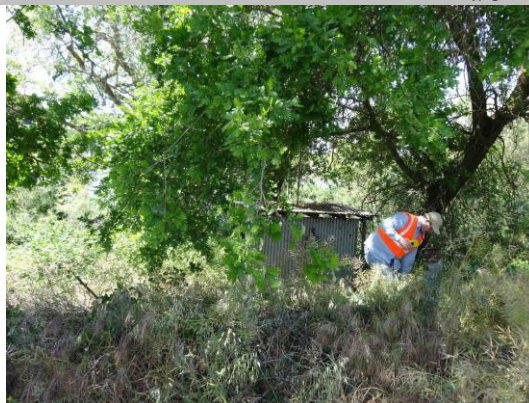
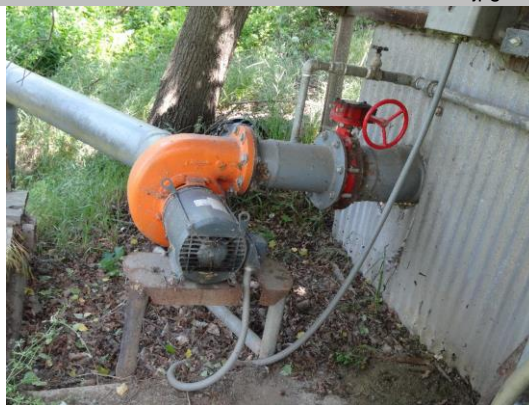
LM Start	2.42	Rating **	M	Issue No.	100
LM End	2.42	Issue Type +	En	Location *	WS
Category	Supplemental			GPS Latitude/Longitude	
				Start	End
Item	DWR UCIP Field Study			38.235261 °	38.235261 °
				-121.558059 °	-121.558059 °
DWR ID					
Comment Code					
Inspector Comment					
FS_ID:12574					
DS_ID:20859					
EP_NO: 11181					
Repair Type: Non-Urgent					
Crossing Status: Found					
UCIP Comments: - Needs to clean CMP riser for proper functioning of siphon breaker.					
FIELD_STRUCT_DESC: A 10-inch steel irrigation pipe through levee, 5.8 feet below crown. Pump and gate valve in pump house on waterward slope. Siphon breaker and service pole on landward slope. (ABO #11181- Collins.). O&M Manual Sac 103, June 1954.					
FS Date: 4/25/2013

WS- pump house on levee berm

WS- pump, and gate valve in pump house.

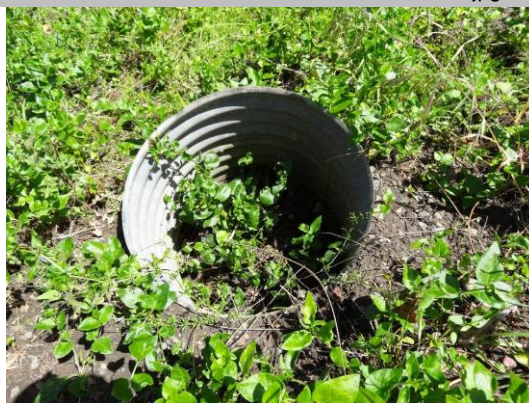
Photo 2 of 2 : UCIP\_SP\_2016\_41713\_20283.jpg

FS\_ID:41713  
DS\_ID:20849  
EP\_NO: 11181  
Repair Type: Non-Urgent  
Crossing Status: Found  
UCIP Comments: - Needs to clean siphon breaker CMP riser.  
FIELD\_STRUCT\_DESC: A 6-inch pipe through levee, 6.0 feet below crown. Pressure tank in pump house on waterward berm. Service pole, siphon breaker and distribution box on landward slope. (ABO #11181 - Collins.)  
FS Date: 4/25/2013

LS- siphon breaker in CMP riser on levee slope.

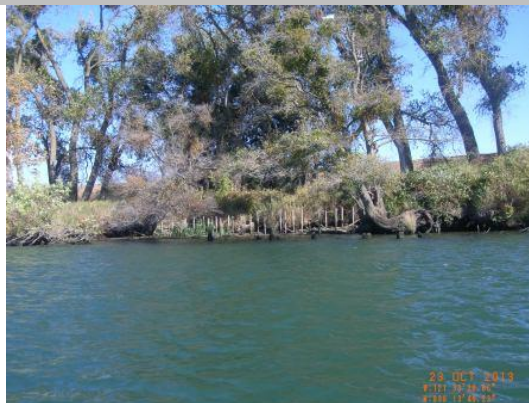
Photo 1 of 1 : SP\_2016\_RD0556\_19\_11\_20160223\_00009.jpg

LM Start	2.93	Rating **	M	Issue No.	11
LM End	3.04	Issue Type +	Ma	Location *	WS
Category	Supplemental			GPS Latitude/Longitude	
				Start	End
Item	2015 USACE Erosion Survey, DRAFT			38.228202 °	38.226601 °
				-121.555502 °	-121.555605 °
DWR ID	DWR_RD0556_02_s_2016_11				
Comment Code					
Inspector Comment					
1997 - Few scallops in berm, some getting close to levee toe. 2005 - Brush boxes present. 2012 - More erosion of the toe since last year. 2015: No observed changes. [2015 Site ID: SAC_23-3_L]

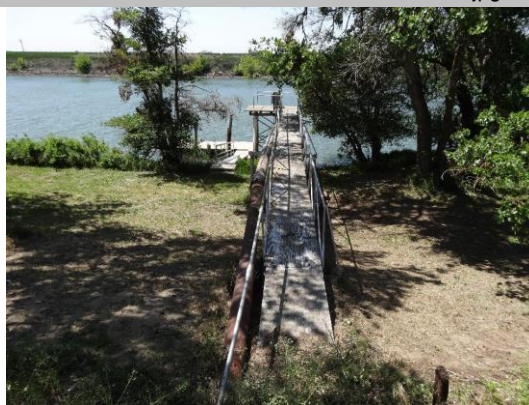
Photo 1 of 2 : UCIP\_SP\_2016\_12525\_20290.jpg

LM Start	3.07	Rating **	M	Issue No.	91
LM End	3.07	Issue Type +	En	Location *	WS
Category	Supplemental			GPS Latitude/Longitude	
				Start	End
Item	DWR UCIP Field Study			38.226225 °	38.226225 °
				-121.555236 °	-121.555236 °
DWR ID					
Comment Code					
Inspector Comment					
FS_ID:12525 DS_ID:20862 EP_NO: N/A Repair Type: Non-Urgent Crossing Status: Found UCIP Comments: - 9-inch steel pipe sleeved through 12-inch pipe.- needs to seal gap between two pipes. FIELD_STRUCT_DESC: A 9-inch steel pipe sleeved through 12-inch steel irrigation pipe through levee, 6.0 feet below crown. Pump on pile structure in stream. Steel walkway to pump, wood steps on waterward slope. Concrete spillbox with 2- 8 inch openings. (ABO #11193-Reid.). O&M Manual Sac 103, June 1954. FS Date: 4/25/2013

WS- walkway, pump, and pipe on steel pile structure in the river.

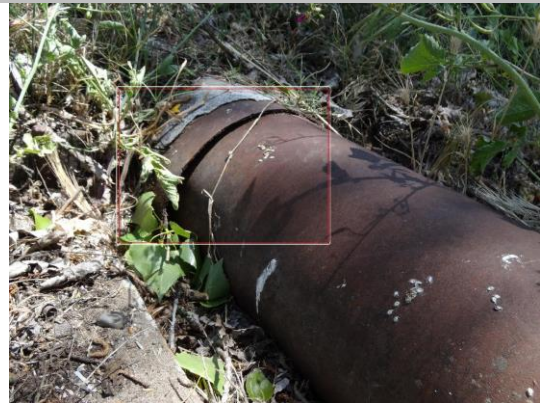
Photo 2 of 2 : UCIP\_SP\_2016\_12525\_20289.jpg

LM Start	3.07	Rating **	M	Issue No.	91 (cont)
LM End	3.07	Issue Type +	En	Location *	WS
Category	Supplemental			GPS Latitude/Longitude	
				Start	End
Item	DWR UCIP Field Study			38.226225 °	38.226225 °
				-121.555236 °	-121.555236 °
DWR ID					
Comment Code					
Inspector Comment					
FS_ID:12525 DS_ID:20862 EP_NO: N/A Repair Type: Non-Urgent Crossing Status: Found UCIP Comments: - 9-inch steel pipe sleeved through 12-inch pipe.- needs to seal gap between two pipes. FIELD_STRUCT_DESC: A 9-inch steel pipe sleeved through 12-inch steel irrigation pipe through levee, 6.0 feet below crown. Pump on pile structure in stream. Steel walkway to pump, wood steps on waterward slope. Concrete spillbox with 2- 8 inch openings. (ABO #11193-Reid.). O&M Manual Sac 103, June 1954. FS Date: 4/25/2013

WS- 9-inch pipe sleeved through 10 inch steel pipe.

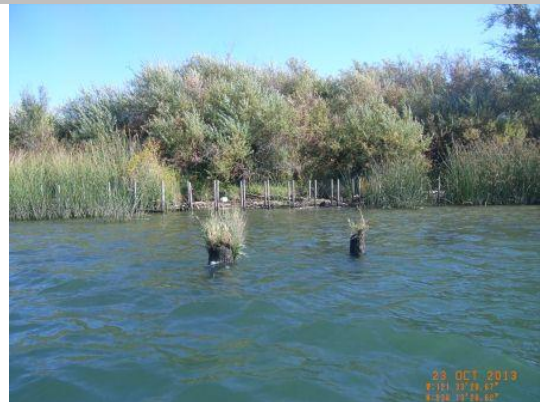
Photo 1 of 1 : SP\_2016\_RD0556\_19\_10\_20160223\_00008.jpg

LM Start	3.17	Rating **	M	Issue No.	10
LM End	3.28	Issue Type +	Ma	Location *	WS
Category	Supplemental			GPS Latitude/Longitude	
				Start	End
Item	2015 USACE Erosion Survey, DRAFT			38.224850 °	38.223233 °
				-121.555641 °	-121.555687 °
DWR ID	DWR_RD0556_02_s_2016_10				
Comment Code					
Inspector Comment					
2000 - Recently fallen cottonwood at the downstream end. 2005 - Empty brush boxes. 2011 - A few trees have fallen since last year. 2012 - Potential new tree popout since last year. 2013 - New erosion at downstream end of site and a recent tree pop-out observed. 2015: No observed changes. [2015 Site ID: SAC_23-2_L]

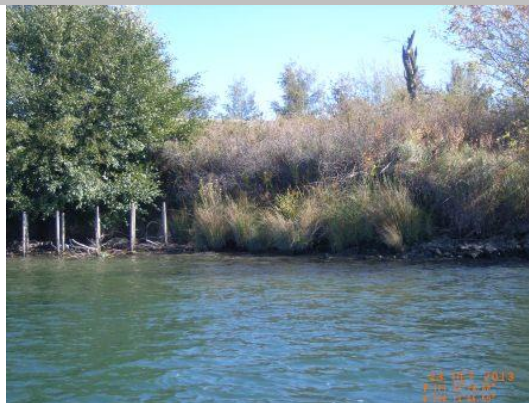
Photo 1 of 1 : SP\_2016\_RD0556\_19\_8\_20160223\_00007.jpg

LM Start	3.58	Rating **	M	Issue No.	8
LM End	3.64	Issue Type +	Ma	Location *	WS
Category	Supplemental			GPS Latitude/Longitude	
				Start	End
Item	2015 USACE Erosion Survey, DRAFT			38.218951 °	38.218104 °
				-121.556689 °	-121.556819 °
DWR ID	DWR_RD0556_02_s_2016_8				
Comment Code					
Inspector Comment					
1997 - Scallops into berm and very close to levee toe. 2005 - Brush boxes present. 2011 - New toe scour and freshly fallen tree. 2012 - New tree popout has taken significant portion of soil out of the levee. 2015: No observed changes. [2015 Site ID: SAC_22-7_L]

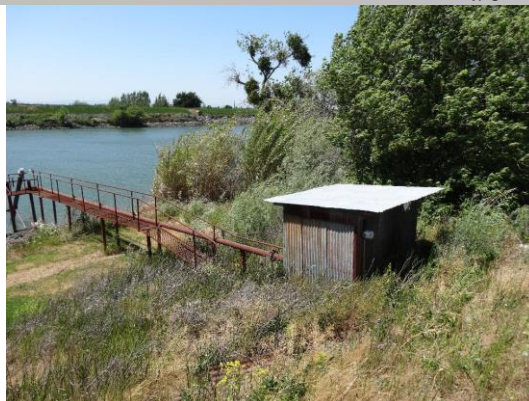
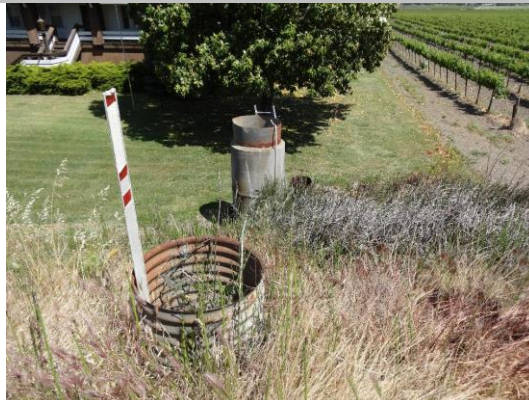
LM Start	3.99	Rating **	M	Issue No.	93
LM End	3.99	Issue Type +	En	Location *	WS
Category	Supplemental			GPS Latitude/Longitude	
				Start	End
Item	DWR UCIP Field Study			38.213031 °	38.213031 °
				-121.556800 °	-121.556800 °
DWR ID					
Comment Code					
Inspector Comment					
FS_ID:12543 DS_ID:20864 EP_NO: 11197 Repair Type: Non-Urgent Crossing Status: Found UCIP Comments: Electric control panel in pump house.Needs cleaning of CMP riser on landside. FIELD_STRUCT_DESC: A 6-inch steel irrigation pipe through levee 6.5 feet below crown. Slanted pump on steel pile structure in the stream, walkway to the pump, and gate valve in pump house on waterward slope. Siphon breaker and service poles on landward slope. Concrete standpipe on landside. (ABO #11197- Souza.). O&M Manual Sac 103, June 1954. FS Date: 4/25/2013

WS- pipe and pump on steel pile structure. Steel walkway from pump house to the pump on steel structure.

LS- siphon breaker in CMP riser and concrete standpipe behind CMP riser.

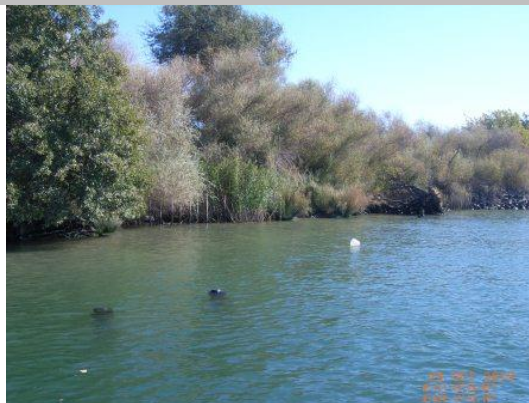
Photo 1 of 1 : SP\_2016\_RD0556\_19\_7\_20160223\_00006.jpg

LM Start	4.45	Rating **	M	Issue No.	7
LM End	4.49	Issue Type +	Ma	Location *	WS
Category	Supplemental			GPS Latitude/Longitude	
				Start	End
Item	2015 USACE Erosion Survey, DRAFT			38.206377 °	38.205729 °
				-121.557184 °	-121.557108 °
DWR ID	DWR_RD0556_02_s_2016_7				
Comment Code					
Inspector Comment					
2013 - Erosion pockets encroaching on levee foundation. 2015: No observed changes. [2015 Site ID: SAC_21-9_L]

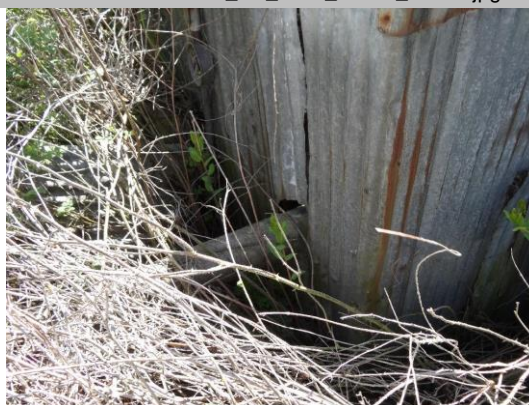
Photo 2 of 2 : UCIP\_SP\_2016\_12546\_20313.jpg

LM Start	4.54	Rating **	M	Issue No.	95
LM End	4.54	Issue Type +	En	Location *	WS
Category	Supplemental			GPS Latitude/Longitude	
				Start	End
Item	DWR UCIP Field Study			38.204974 °	38.204974 °
				-121.556789 °	-121.556789 °
DWR ID					
Comment Code					
Inspector Comment					
FS_ID:12546 DS_ID:20866 EP_NO: 11940 Repair Type: Non-Urgent Crossing Status: Found UCIP Comments: - Abandoned crossing.- Siphon breaker on LS not found due to dense vegetation, - An abandoned CMP riser and service pole found on LS.- It may need to be properly abandoned. FIELD_STRUCT_DESC: Abandoned 6-inch pipe through levee, 6.7 feet below crown. Pump and gate valve in pumphouse on waterward slope. Siphon breaker and service pole on landward slope. (ABO # 11940-Robinson.). O&M Manual Sac 103, June 1954. FS Date: 4/25/2013

WS- pipe daylight from levee slope to pump house.

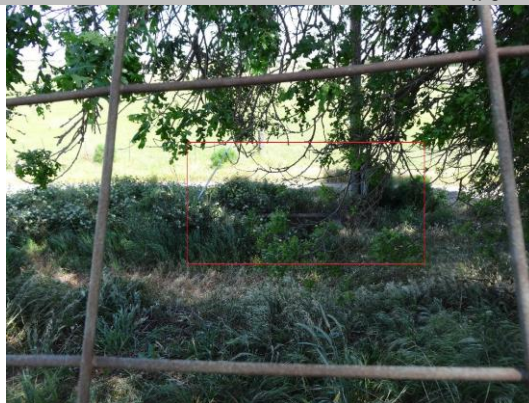
Photo 2 of 2 : UCIP\_SP\_2016\_12547\_20319.jpg

LM Start	4.73	Rating **	M	Issue No.	96 (cont)	
LM End	4.73	Issue Type +	En	Location *	LS	
Category	Supplemental			GPS Latitude/Longitude		
				Start		End
Item	DWR UCIP Field Study			38.202301 °		38.202301 °
				-121.556952 °		-121.556952 °
DWR ID						
Comment Code						
Inspector Comment						
FS_ID:12547 DS_ID:20867 EP_NO: 11199 Repair Type: Non-Urgent Crossing Status: Indicator Found UCIP Comments: - pump, gate valve and pumphouse not found on waterward slope.- an abandoned electric control panel found on WS.- may need to be properly abandoned. FIELD_STRUCT_DESC: A 6-inch steel irrigation pipe through levee, 6.5 feet below crown. Siphon and concrete spill box with 2- 8 inch openings. (ABO #11199- Tokoyoshi.). O&M Manual Sac 103, June 1954. FS Date: 4/25/2013

LS- concrete distribution box near levee toe.

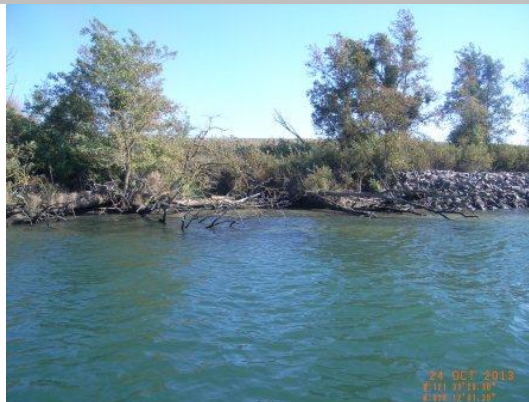
Photo 1 of 1 : SP\_2016\_RD0556\_19\_3\_20160223\_00003.jpg

LM Start	4.77	Rating **	M	Issue No.	3
LM End	4.88	Issue Type +	Ma	Location *	WS
Category	Supplemental			GPS Latitude/Longitude	
				Start	End
Item	2015 USACE Erosion Survey, DRAFT			38.201687 °	38.200225 °
				-121.557305 °	-121.557749 °
DWR ID	DWR_RD0556_02_s_2016_3				
Comment Code					
Inspector Comment					
1999 - Downstream 140 ft repaired with rock. 2010 - Lots of woody debris, but no changes to site. 2015: Site extended upstream due to erosion pockets. [2015 Site ID: SAC_21-5_L]

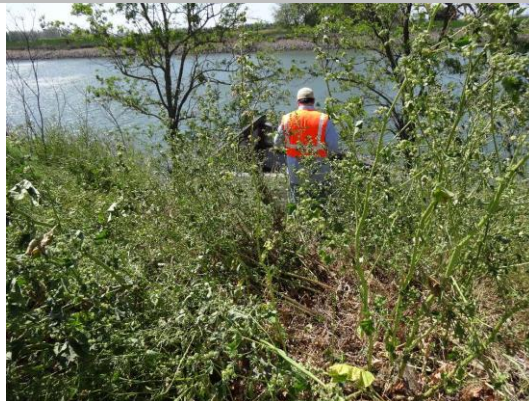
Photo 1 of 2 : UCIP\_SP\_2016\_12564\_20347.jpg

FS\_ID:12564  
DS\_ID:20868  
EP\_NO: 11191  
Repair Type: Non-Urgent  
Crossing Status: Found  
UCIP Comments: - needs to fix CMP riser.  
FIELD\_STRUCT\_DESC: A 8-inch pipe through levee, 5.7 feet below crown. Pump on waterward slope, gate valve on berm. Siphon breaker and service pole on landward slope. (ABO #11191-Pacific Fruit Exchange.)  
FS Date: 4/25/2013

WS- pump house on levee slope.

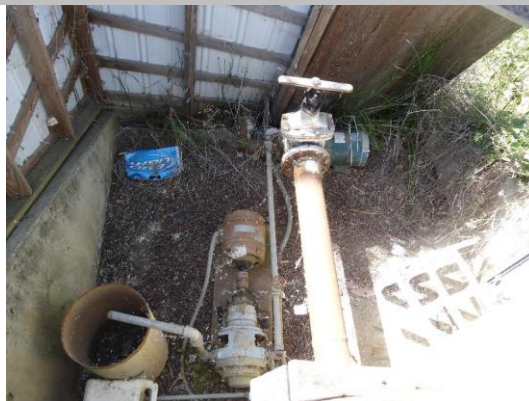
Photo 2 of 2 : UCIP\_SP\_2016\_12564\_20346.jpg

WS- pump, pipe and gate valve in pump house.

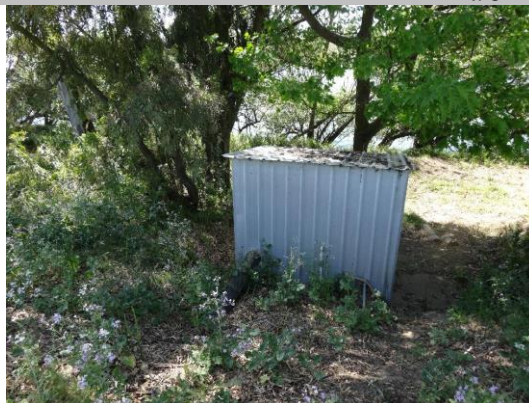
Photo 1 of 2 : UCIP\_SP\_2016\_12570\_20364.jpg

FS\_ID:12570  
DS\_ID:20869  
EP\_NO: 11185  
Repair Type: Urgent  
Crossing Status: Found  
UCIP Comments: Large pit and erosion on WS levee berm.  
FIELD\_STRUCT\_DESC: A 8-inch pipe through levee, 5.7 feet below crown. Pump and gate valve in pumphouse on waterward slope. Siphon breaker, concrete box, and service pole on landward slope. (ABO # 11185- Langhart.)  
FS Date: 4/25/2013

WS- pump house on levee slope

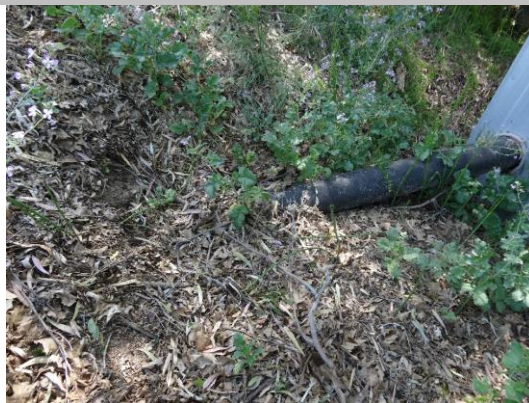
Photo 2 of 2 : UCIP\_SP\_2016\_12570\_20363.jpg

WS- pipe daylight from the levee.
